**Flood Control Project Maintenance
Levee Inspections**
LMA District Cover Sheet
Spring 2018 Levee Inspection Results

Reclamation District No. 2096 Wetherbee Lake

Spring 2018 Levee Inspection Results

Waterway	Bank	Unit Miles	Inspection Start/End	Inspector
Unit No. 01 San Joaquin River	Right	0.16	03/13/2018 03/13/2018	Maksim Khashchuk

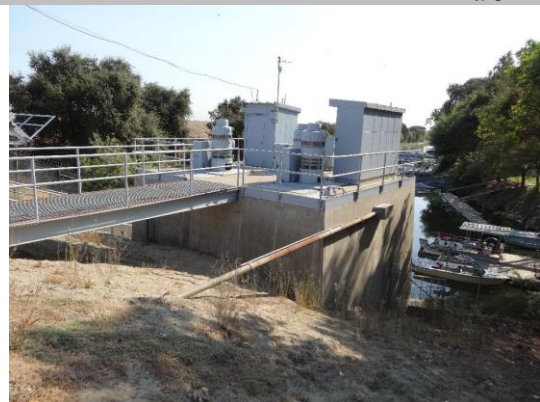
Photo 1 of 2 : UCIP_SP_2018_21506_36453.jpg

LM Start	0.03	Rating **	M	Issue No.	17	
LM End	0.03	Issue Type +	En	Location *		
Category	Supplemental			GPS Latitude/Longitude		
				Start	End	
Item	DWR UCIP Field Study			37.773800 °	37.773800 °	
				-121.298428 °	-121.298428 °	
DWR ID						
Comment Code						
Inspector Comment						
FS_ID:21506						
DS_ID:24666						
EP_NO: N/A						
Repair Type: Non-Urgent						
Crossing Status: Found						
UCIP Comments: - more information needs to be find from LMA/DWR						
Inspector for this crossing. - needs to find whether this pipe passes						
through the levee.						
FIELD_STRUCT_DESC: 4-inch steel pipe of an unknown purpose						
through the levee and to the pump platform, 3 feet below the crown. It is						
an element of the pumping plant. Field study discovered utility crossing.						
FS Date: 9/10/2013

LS view: 4-inch steel pipe (right) through the levee and to pump platform.

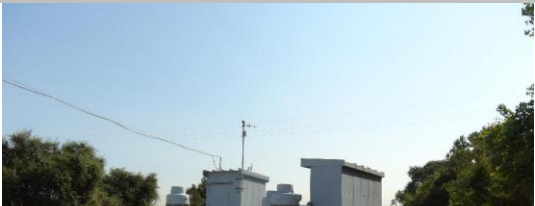
Photo 2 of 2 : UCIP_SP_2018_21506_36452.jpg

LS view: closer view of 4-inch steel pipe (left) through the levee and to pump platform.

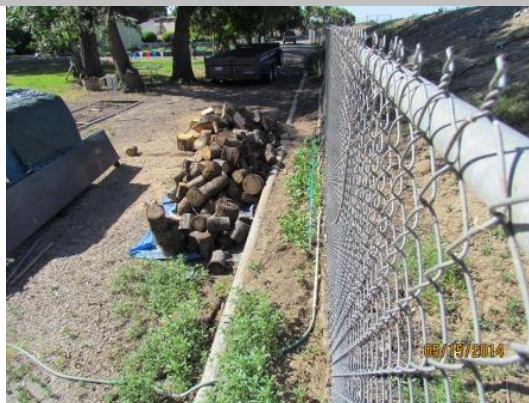
Photo 1 of 1 : SP_2018_RD2096_117_13_20180305_00007.jpg

LM Start	0.08	Rating **	M	Issue No.	13
LM End	0.08	Issue Type +	En	Location *	LS
Category	Earthen Levee			GPS Latitude/Longitude	
				Start	End
Item	Encroachments			37.773021 °	37.773021 °
				-121.298430 °	-121.298430 °
DWR ID	DWR_RD2096_01_s_2014_13				
Comment Code					
RW : Retaining Wall					
Inspector Comment					
Abut 1 foot by 50 feet retaining wall at levee toe with irrigation and landscaping.

View of the retaining wall at the landside levee toe.
